CASE STUDY: Wholesale Retailer

LOCATION: Southgate, MI

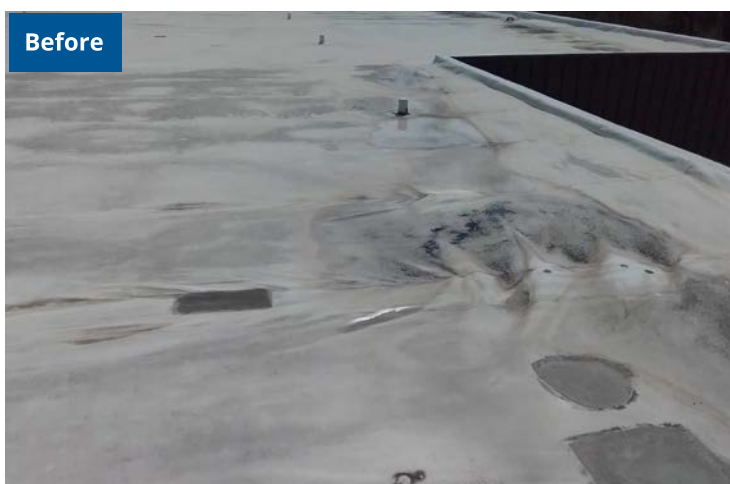
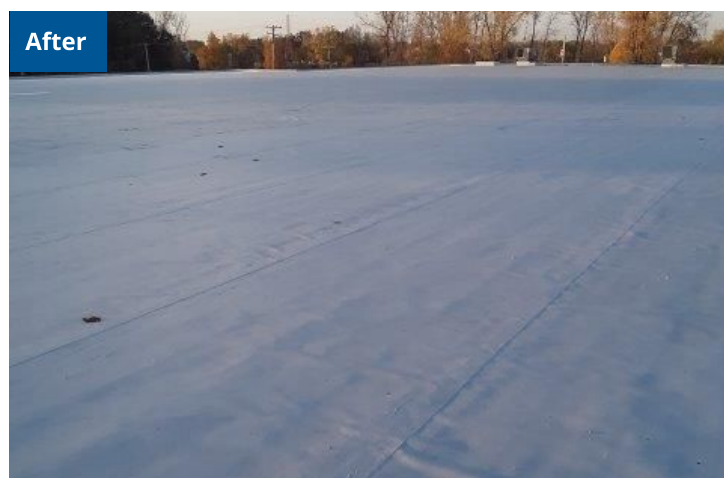
This large wholesale retail facility had widespread roof leaks that were impacting retail and operation areas. The initial roof installed was a built-up roof (BUR) system but a PVC roof system had been placed over it. It was unclear which roof system was causing the issues but regardless of that, a full tear-off and replacement would be extremely costly.

To properly evaluate the situation and recommend the smartest solution, a full SR PreVision inspection and analysis was required. Through a combination of visual inspections, infrared scanning and laboratory testing of the membrane sample, it was determined that the PVC membrane was extremely brittle and was at the end of its useful life. It was also discovered that there was approximately 500 sq. ft. of wet insulation on the roof that needed to be removed as soon as possible. By taking a core sample from the roof, the SR PreVision scientists determined that the initial BUR system was still in good condition and a layover roof system was possible.

The process began with Simon Roofing first removing the wet insulation and replacing it with new insulation to match the existing roof height in those areas. Then, the entire PVC roof membrane was removed down to the original BUR system. Technicians installed the CLP (cross link polymer) roof system directly over the existing roof. Flashing was performed around the perimeter and all penetrations and drains received a multi-course application of Wite Brite™ Cement and reinforced polyester fabric for added protection. Finally, a final application of Wite Brite™ coating was applied to create a seamless membrane over the entire roof.
