CASE STUDY: Foundry Office Building

LOCATION: Kutztown, PA

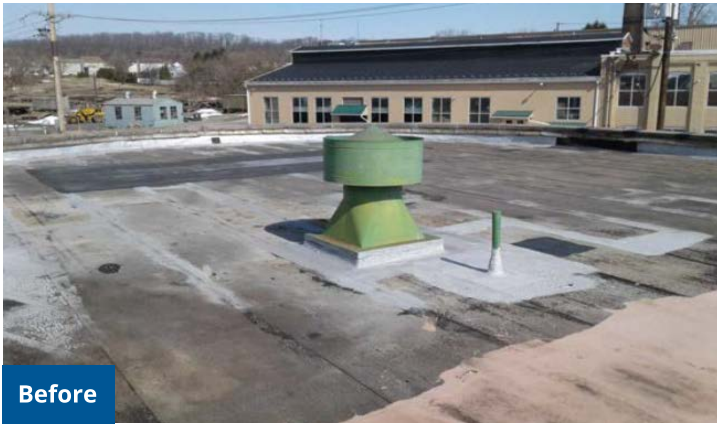
Before

The office building of the foundry was experiencing multiple roof leaks. It was disruptive to business and the reactive approach to repairing the leaks was becoming costly and time-consuming.

First, a SR PreVision inspection and analysis were performed on the roof section. This comprehensive process includes a visual inspection, infrared scans, core membrane sample testing in our laboratory and an extensive condition report outlining the findings. It was determined that the roof was beyond repair and a tear-off and replacement was the smartest solution.

After completing the asbestos testing and other safety requirements, Simon Roofing removed the existing roof down to the deck. New insulation was installed, followed by our signature CLP (Cross Linked Polymer), which is a superior alternative to traditional single-ply roof systems that offers better weathering, more waterproofing and enhanced performance. After mechanically attaching the CLP sheet, one layer of Wite Brite™ elastomeric coating was applied across the roof section to create a seamless and watertight surface.
