CASE STUDY: Retirement Community

LOCATION: MONTGOMERY, AL

CLP+™20 Tapered System

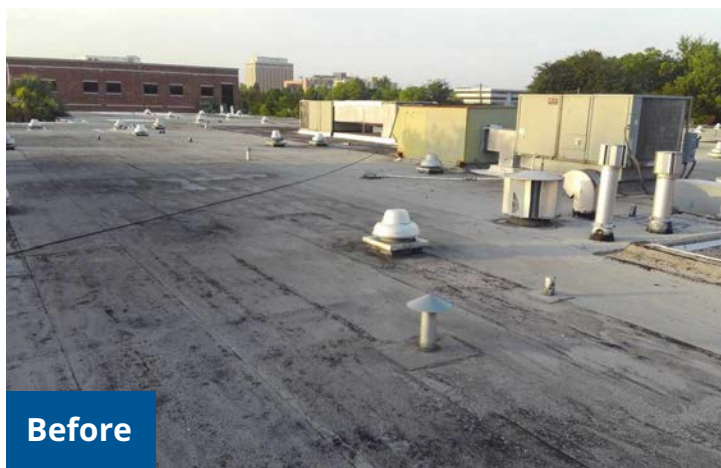
Simon Roofing first performed its extensive SR PreVision inspection and analysis. 90% of the roof's surface was experiencing ponding water and infrared scanning determined that a large amount of wet insulation was present. Plus, the roof had originally been poorly designed and had not been tapered to prevent water from ponding and sitting stagnant on the roof.

Simon Roofing tore off the existing roof system and installed its CLP+ 20 system. The CLP+ systems are a cross-linked polymer alternative to traditional single-ply roof systems. The system was also tapered to allow water to properly run off of the roof. The entire project was completed in under 8 weeks and disruption was minimized, which was essential to this nursing home facility.

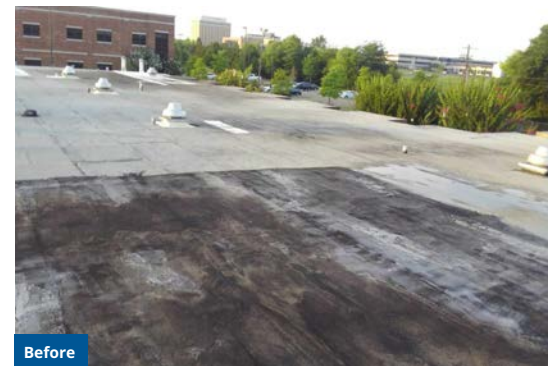
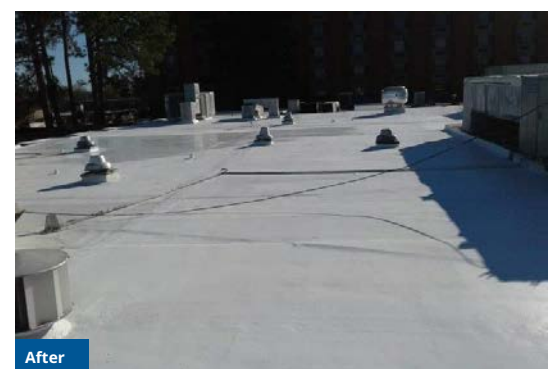
- Ponding water and wet insulation issues resolved
- Stronger and seamless alternative to single-ply
- 20 year labor, workmanship and materials warranty
- Minimal disruption to business
