CASE STUDY: Office Building

LOCATION: Lynnwood, WA

SR 461 Restoration

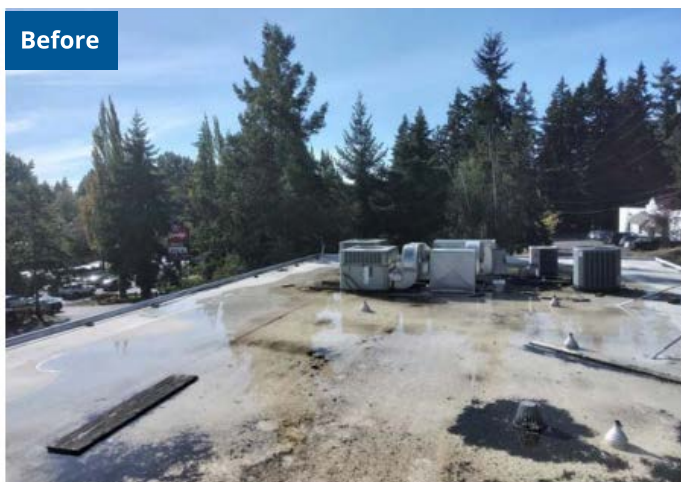
Before

This office building housing a property management firm was experiencing multiple leaks. The roof also had ponding water issues, which could significantly speed up the aging process of a roof membrane.
