# CASE STUDY: Recycling Facility

LOCATION: Seattle, WA

SR 461a Restoration + Repairs

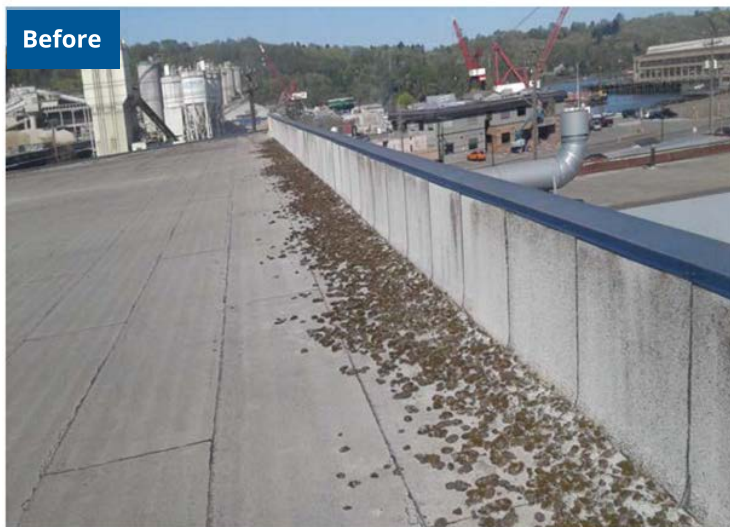
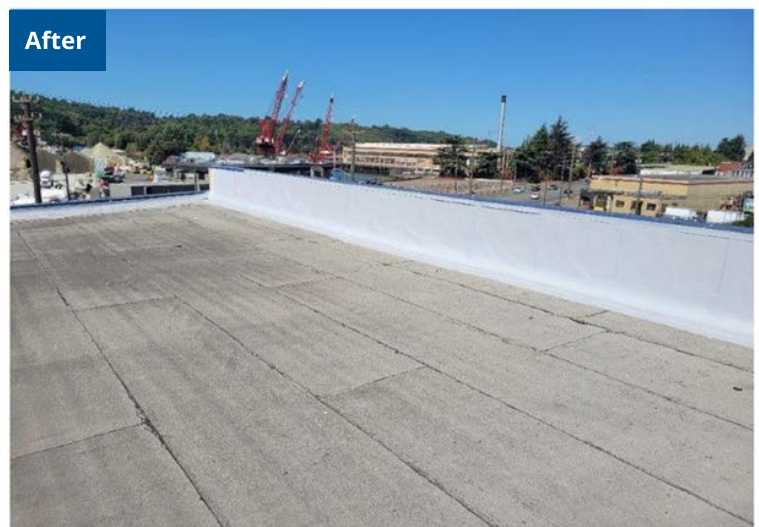
The recycling facility had widespread leaks that were impacting operations. Three roofing providers had performed inspections and all had concluded the roof needed to be replaced. The customer wasn't satisfied with their conclusions.

Simon Roofing was asked to perform its extensive SR PreVision inspection and analysis, which consists of visual inspections, infrared scans and roof membrane sample testing. All of these factors are combined into one comprehensive report to determine existing useful life, conditions of each roof section and opportunities for repairs or restorations when possible.

Based on the findings provided by the SR PreVision analysis, it was determined that there were still years of useful life remaining in the current roof system, and a series of defects were contributing to the current leak issues. Fortunately, these issues could be resolved with a combination approach of repairs and restorations.

Simon Roofing performed its SR 461a restoration solution to the roof section above the office. In addition, flashing repairs were made on the larger warehouse roof. The combination of the two extended the roof's service life for another 13+ years before a longer-term solution would be needed.
