CASE STUDY: DATA CENTER

LOCATION: DURHAM, NC

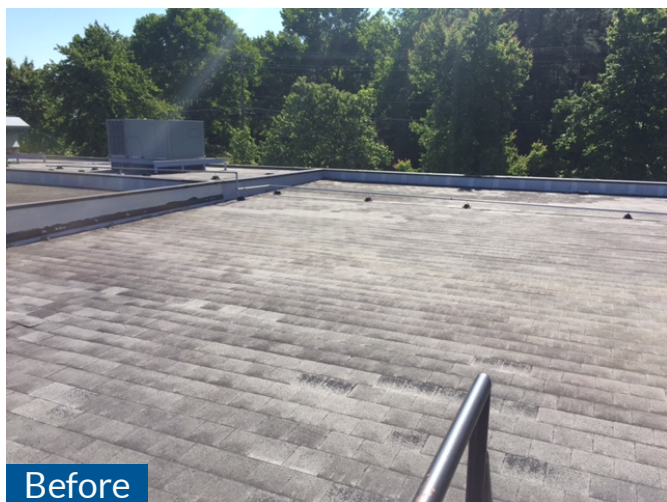
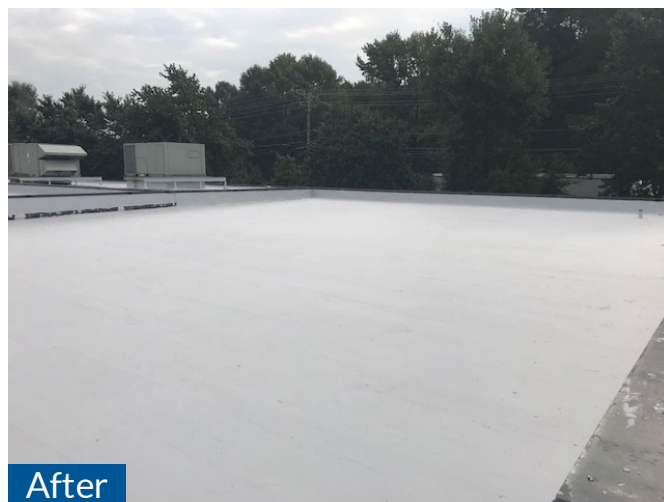
A large data center was experiencing significant challenges on its roof due to heavy concrete pavers. These pavers were originally installed on the roof to protect it from ice falling from a tower near the building. They were causing stress at the flashing points due to building movement and were driving up repair costs. These unique needs meant a simple one-size-fits-all roof wouldn't be the answer. Plus, as a data center, it was imperative that the roof was watertight because even just one leak could be detrimental.

Simon Roofing's experts developed a custom solution that would eliminate the concrete pavers but still provide protection for the entire roof, including those critical areas. First, Simon Roofing removed approximately 35,000 sq. ft. of concrete pavers across various roof sections. Starting with the first area, Simon Roofing installed ¼" roof board, followed by the SR 435a system, which consists of multiple layers of SuperiorPly Ultra membrane, SR Poly and Wite Brite™ coating. On the remaining sections, Simon Roofing installed the SR 463c system, which consists of one layer of SR Flood Coat, SR Poly and multiple layers of Wite Brite™ coating. After completion, the roof was more structurally sound without the weight of the concrete pavers, as well as more resistant to punctures and foot traffic. The Wite Brite™ coatings created a seamless surface across all roof sections designed to reduce the possibilities of leaks.
