# CASE STUDY: SUMMIT HOTEL PROPERTIES

LOCATION: NEW ORLEANS, LA

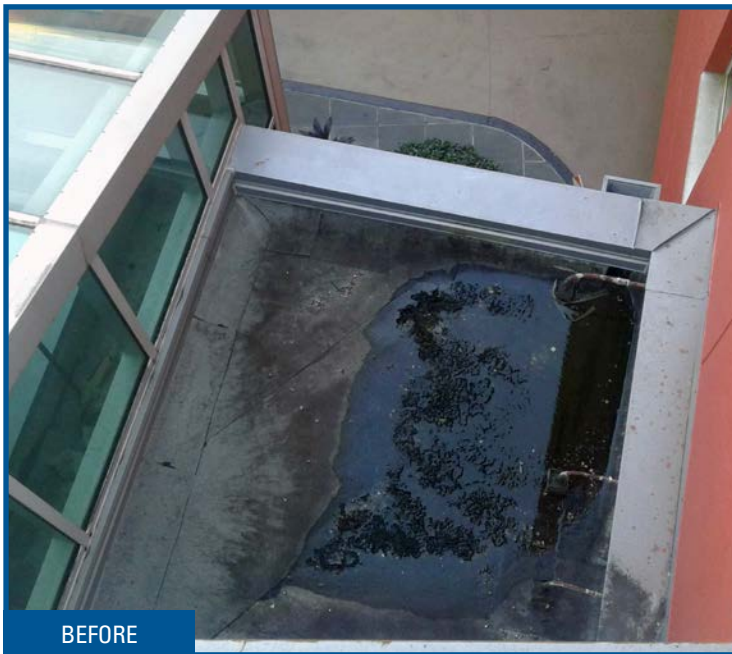
The Courtyard New Orleans hotel had a small roof section that was causing a significant number of leaks. The section, however, was difficult to access because it was located in the middle of the building and at a lower level than other roof sections.

Simon Roofing was able to create a customized solution and access just the small problem section effectively and even more importantly, safely. Technicians installed the SR 117aw system, which includes Simon Roofing's own CLP™+ sheet and Wite Brite™ coating. The CLP™+ sheet is a Cross Link Polymer alternative to standard single-ply systems.
