## CASE STUDY:

# Concordia University

LOCATION: PORTLAND, OR

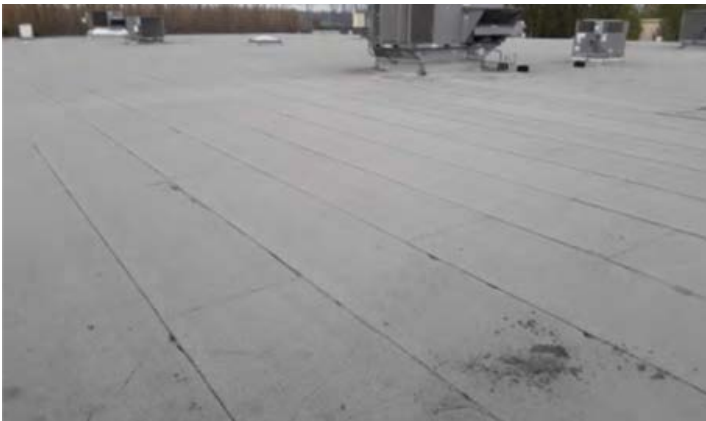
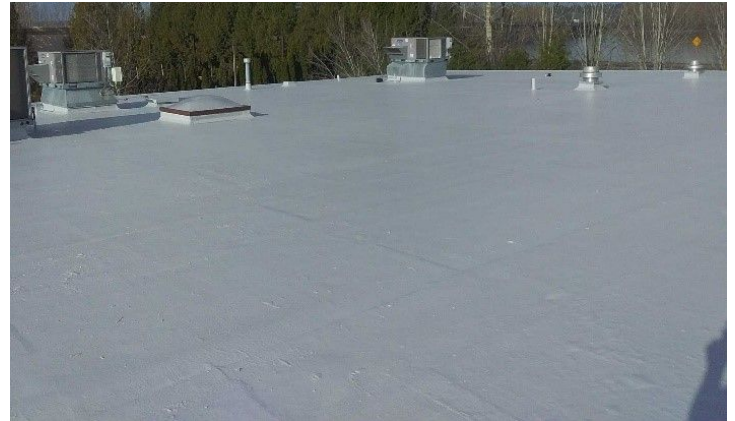
This lecture hall at Concordia University had experienced several roof leaks over recent years. The building was actually in the process of being sold so the roofing issues needed to be addressed. The existing roof was an asphalt built-up roof (BUR). A roofing provider had recommended a completely new roof system be laid over the existing roof. Not only was this costly, but the recommended system was a torch down BUR, meaning all seams would be torched across the roof. This process actually breaks down the system because of the intense heat and will lead to water intrusion.

Based upon the roof type, location and building demands, the SR 461t restoration was the smartest solution. This restoration is made up of multiple layers of Wite Brite™ elastomeric coating and SR Polyester to create a seamless surface across the roof, paying special attention to common weak spots of the roof. The SR 461t solution also comes with a full 20-year labor, workmanship and materials warranty, which Simon Roofing can offer because it is both the manufacturer and installer of its materials.
