CASE STUDY:

XAVIER UNIVERSITY OF LOUISIANA

LOCATION: NEW ORLEANS, LA

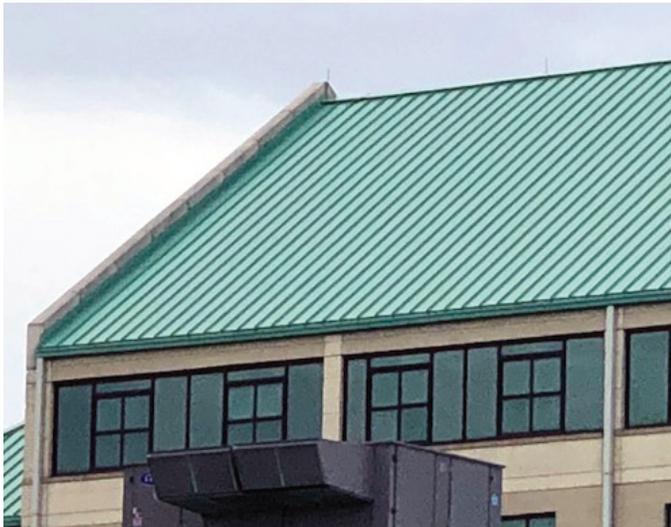
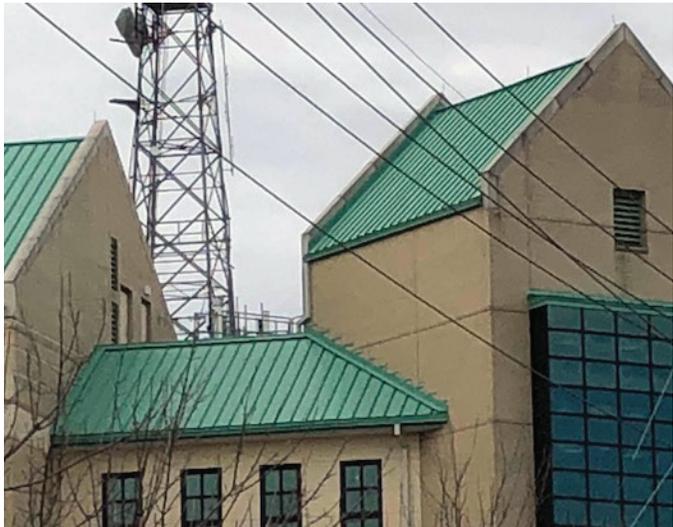
Xavier University was experiencing metal roof leaks on five campus buildings that included residence halls, classrooms and the University Center, which consists of a dining hall, special events ballroom, bookstore, student lounges and administrative office space. Because the metal roofs are high-pitched, they are very visible from the ground so a standard repair on the signature green color roofs would make them unattractive from the street.

Simon Roofing was able to both color-match the roofs' signature green, even though it was aged and weathered, and produce the custom roof repair material in their manufacturing facility within a few days. The roof repairs performed were 6" three-course, meaning a layer of repair material, followed by embedded polyester and another layer of repair material along the step flashing where it meets the masonry. The solution brought the metal roofs back to watertight condition and since the color match was a success, the repairs are not visible from the ground.
